COMPOSITE JOIST PROJECT

SPONSORED BY STEEL JOIST INSTITUTE

INTERPRETATION OF COMPOSITE JOIST TEST RESULTS

September 1967

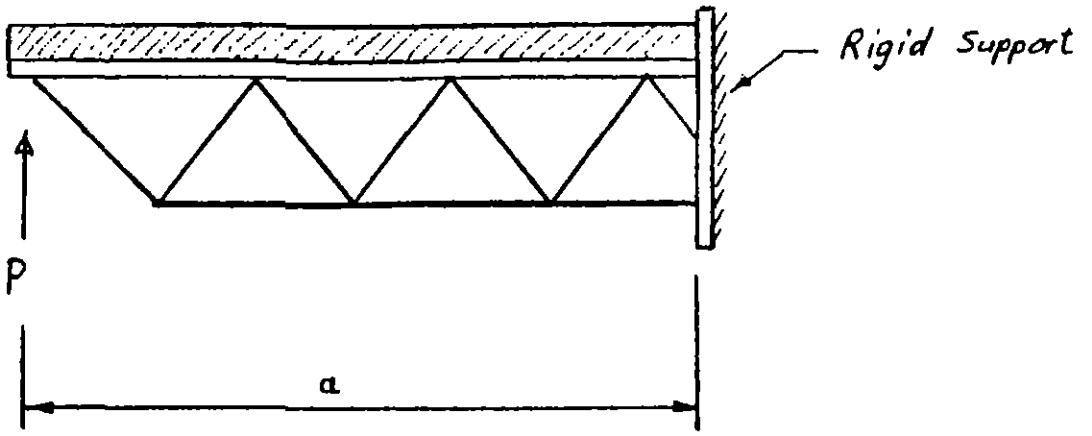
Fig. 1 Schematic View of Cantilever Tests

1) Cantilever tests (Fig. 1)

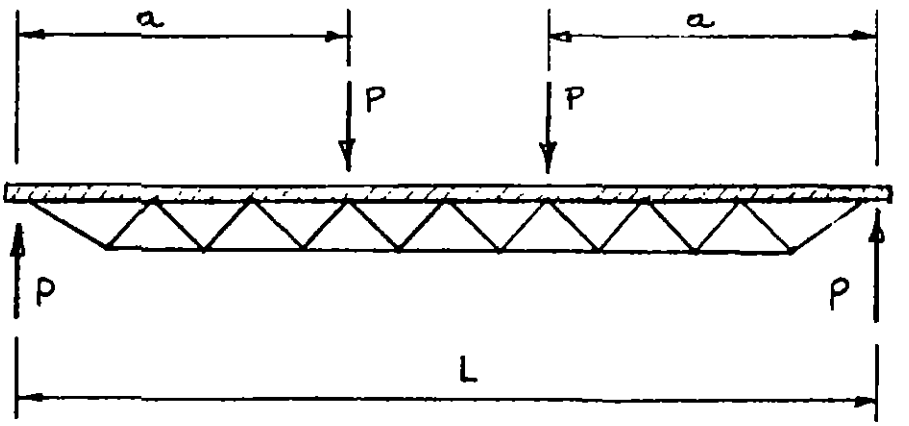
Fig. 2 Schematic View of Beam Tests

2) Beam tests (Fig. 2)

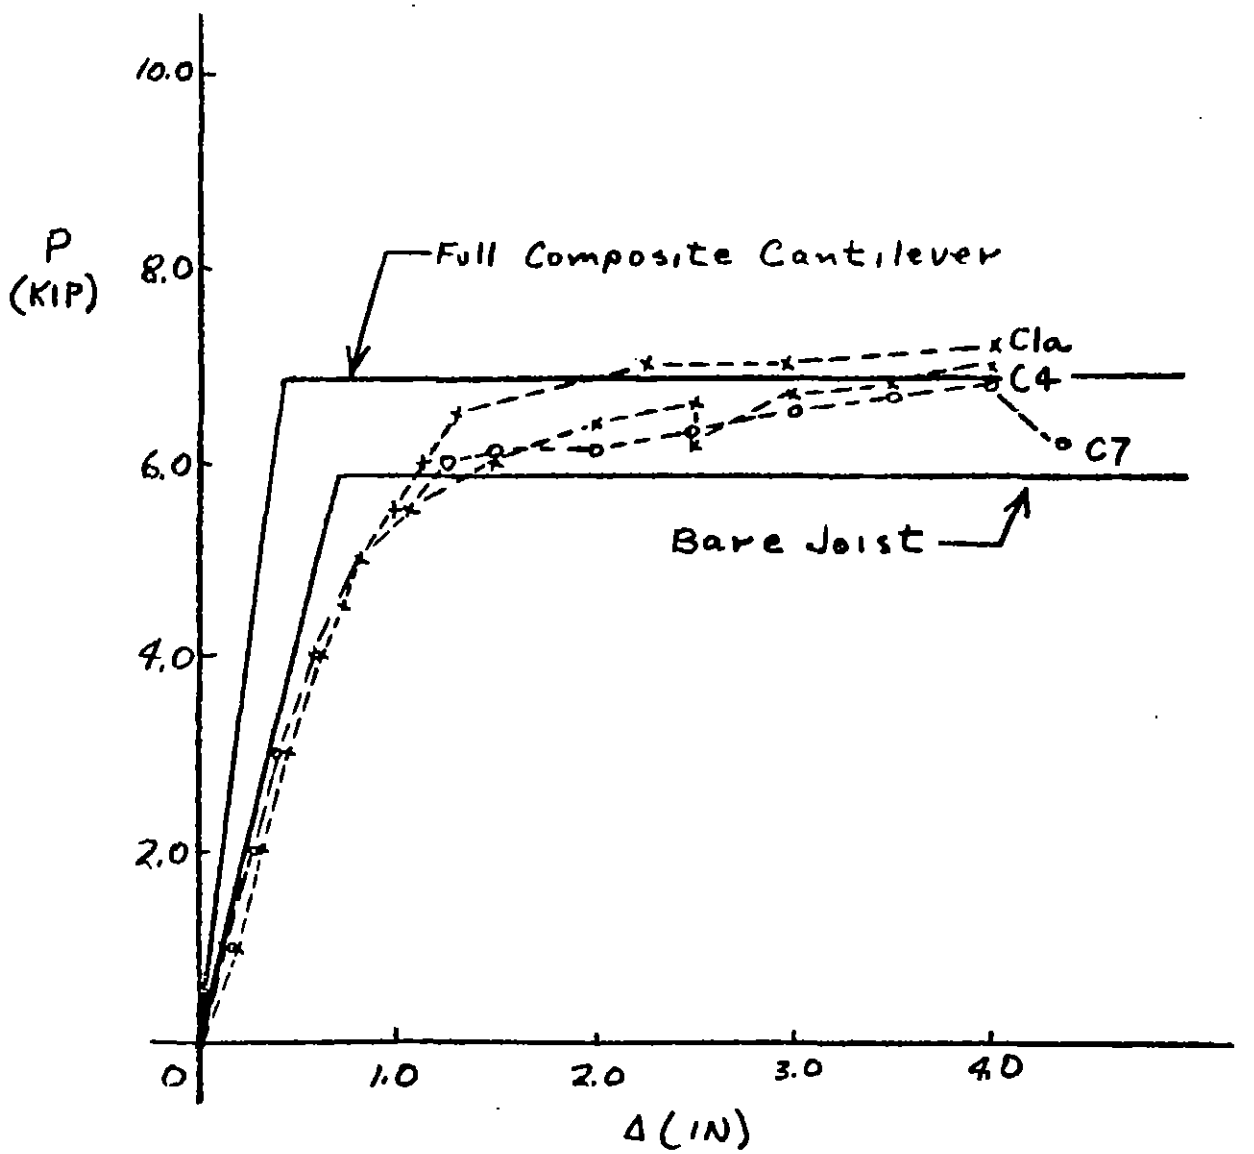
FIG 4a Load - Deflection Diagram for Cantilevers

The experimental load deflection curves are recorded in Figs. 4, grouped into tests with similar joists. Also shown in these figures are theoretical curves based on the assumption of (1) zero interaction and (2) complete interaction.
